Case Study:

Use of Cutting Edge Precision Alignment Technology for Total Knee Arthroplasty

- Michael Ast, M.D. | Capital Health Medical Center, Hopewell, NJ

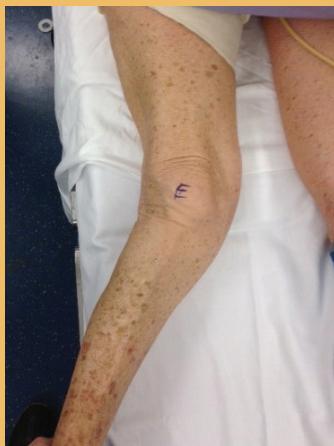
Figure 1

X-rays were taken which showed collapse of the lateral femoral condyle and severe DJD. There was good healing of the prior distal femur fracture. There was significant valgus deformity. The hardware in place consisted of a distal femoral locking plate running almost the entire length of the femur. There were also four smaller screws that appear to be outside of the plate crossing perpendicular to the fracture site.

Patient is an 80-year old female who sustained a right distal femur fracture and underwent a successful ORIF about 1 year ago. Fracture healed uneventfully, but presented with increasing right knee pain and deformity and increasing inability to ambulate (Figure 1, Figure 2). She complained of severe pain when walking on uneven surfaces or trying to go up and down stairs. She denied any signs or symptoms of infections.

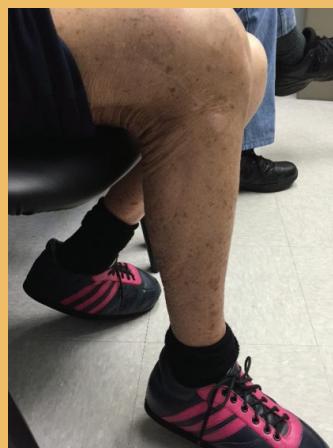
Figure 4

Postoperative clinical exam and x-rays showed good positioning of all components and excellent long-leg alignment. The patient returned at six weeks with greater than 90 degrees of flexion and full extension (Figure 3, Figure 4, Figure 5) and said, "I cannot remember the last time my knee didn't hurt and was so straight!"
