# CASE STUDIES

## KneeAlign<sup>®</sup>

# Severe valgus deformity with retained large distal femoral locking plate

## Case study 1

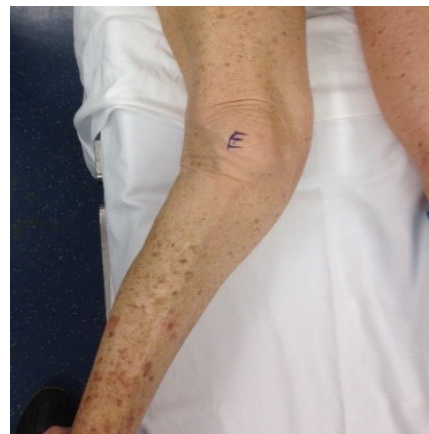
^ Pre-Op Clinical Photo

The patient presented with significant pain and difficulty walking even with a cane or walker. She had a severe valgus deformity with a valgus thrust and mild recurvatum of the knee. On exam, she had significant crepitus and limited ROM. Her prior incisions were well healed without evidence of erythema or drainage.

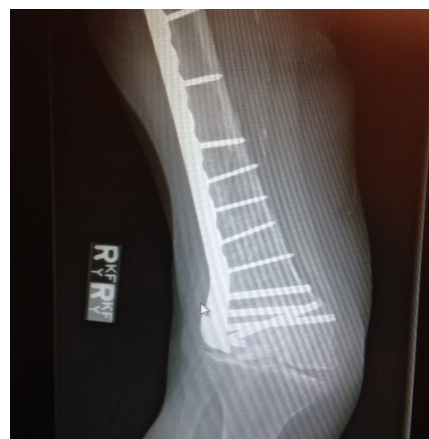
X-rays were taken showing collapse of the lateral femoral condyle and severe DJD. There was good healing of the prior distal femur fracture. There was significant valgus deformity. The hardware in place consisted of a distal femoral locking plate running almost the entire length of the femur. There were also four smaller screws that appear to be outside of the plate crossing perpendicular to the fracture site.

^ Pre-Op AP X-Ray

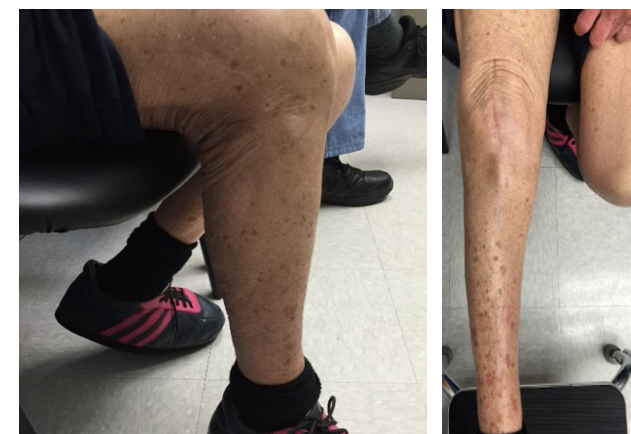
^> Post-Op Clinical Photos

At the 6-week postoperative clinical exam, the x-rays showed good positioning of all components and excellent long-leg alignment. The patient returned at six weeks with greater than 90 degrees of flexion and full extension and said, "I cannot remember the last time my knee didn't hurt and was so straight!"

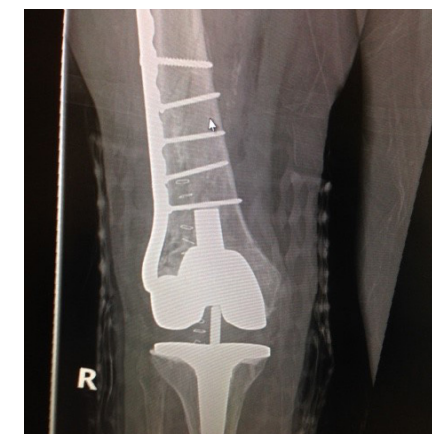
^ Post-Op AP X-ray

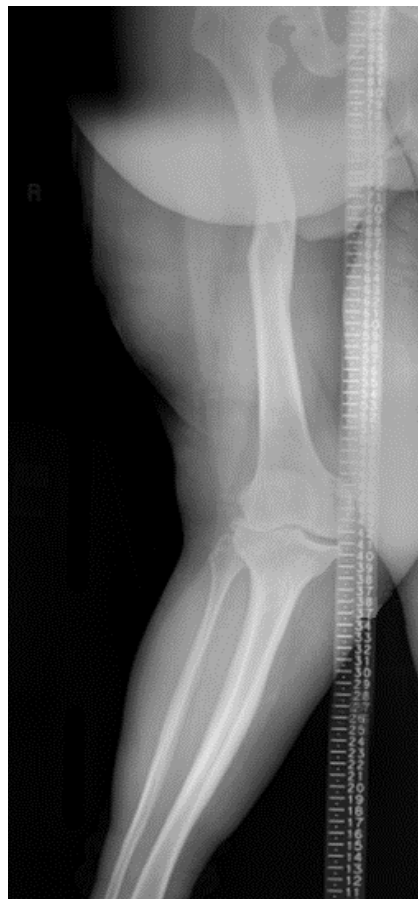
^ Pre-op AP X-ray

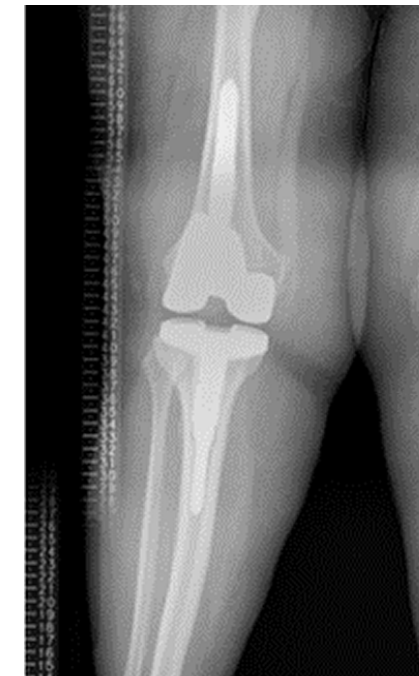
At the 6-week follow-up, postoperative long leg films demonstrated restoration of proper long leg alignment with the mechanical axis going through the center of the knee. Clinically, the patient is now 3 months post-op and ambulating without assistive devices and has 0° – 130° range of motion. Patient said that he likes having a “straight leg” again.

^ Post-op AP X-ray

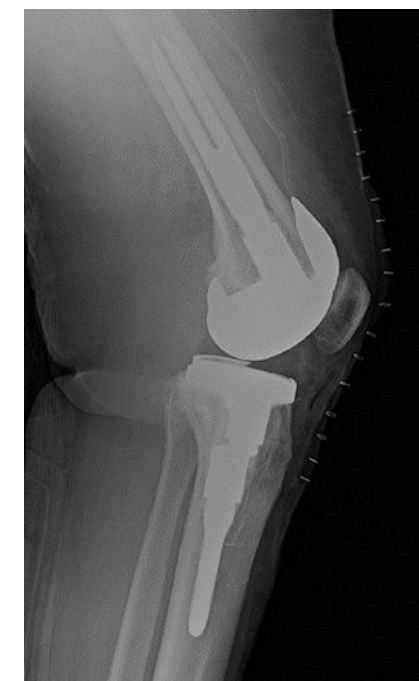
^ Post-op Lateral X-ray

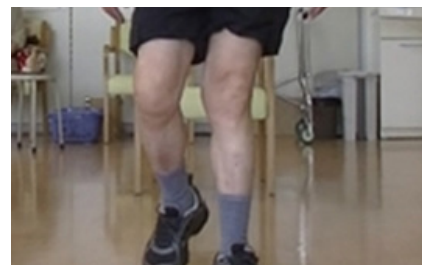
^ Pre-op clinical photo

The patient is a 73-year-old male who suffered from left femoral fracture due to MVA at 19-years-old and sustained severe valgus deformity for 54 years after ORIF in another hospital. He started to feel persistent pain on his left knee 10 years ago and it worsened, year by year. He is still working in a chopstick manufacturing company.

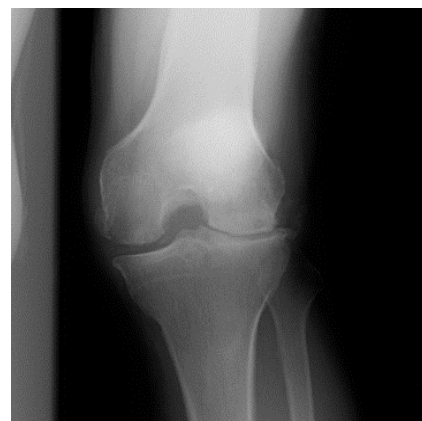
^ Pre-Op AP X-ray

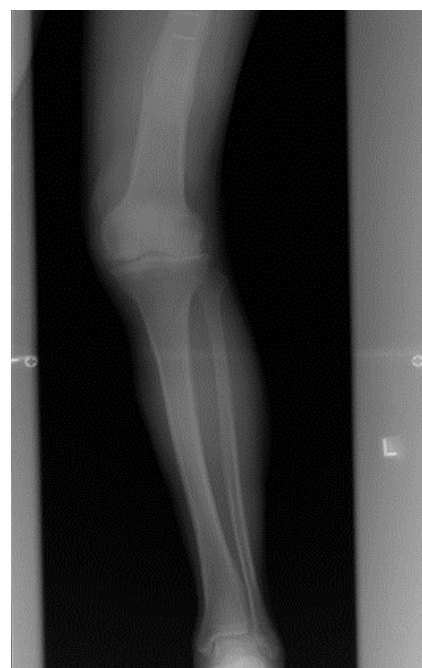
^ Pre-Op standing, weight-bearing AP X-ray

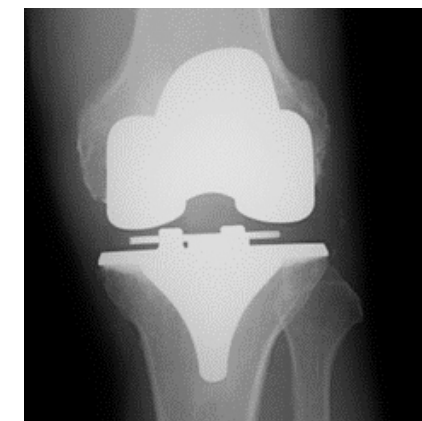
^ Post-Op AP X-ray

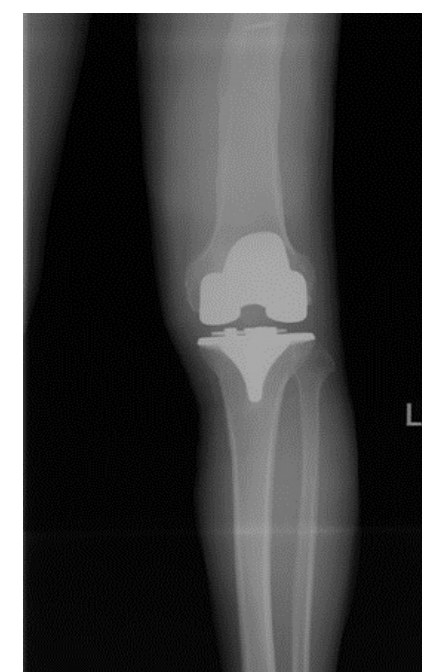
The HKA angle improved to 180°. The  $\alpha$ ,  $\beta$ ,  $\gamma$ ,  $\delta$ , setting angles were 98°, 89°, 7.8°, and 88°, respectively. Final CTA was 4° on the postoperative epicondylar view and lift off angle was 0°.

^ Post-Op standing, weight-bearing AP X-ray

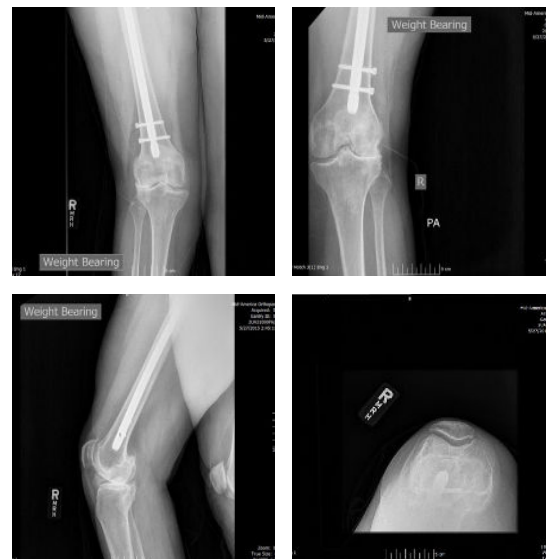
^ Case #1, Pre-Op X-rays

The patient is a 52 year-old female, presenting with a chief complaint of right knee pain. She had a remote history of right intertrochanteric hip fracture, treated surgically with a long antegrade cephalomedullary fixation nail. Her fracture did proceed to union, and she was able to bear weight on the affected extremity, as tolerated. However, since her previous surgery, she did go on to develop anterior and lateral right knee pain that she described as dull, constant, and aching.

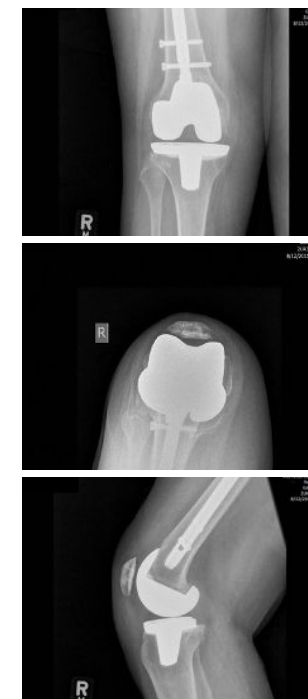
^ Case #1, Post-Op X-rays

At her six week post-operative visit, the patient was doing well and was pain free. Her incision had healed without any complications. She had been performing outpatient physical therapy and achieved good range of motion from 0-125 degrees. Her knee was stable on exam and well-aligned radiographically. She was walking unlimited distances with a cane and she was using stairs in a reciprocal manner with a rail. Her objective Knee Society Score was 100 and her functional Knee Society Score was 85.

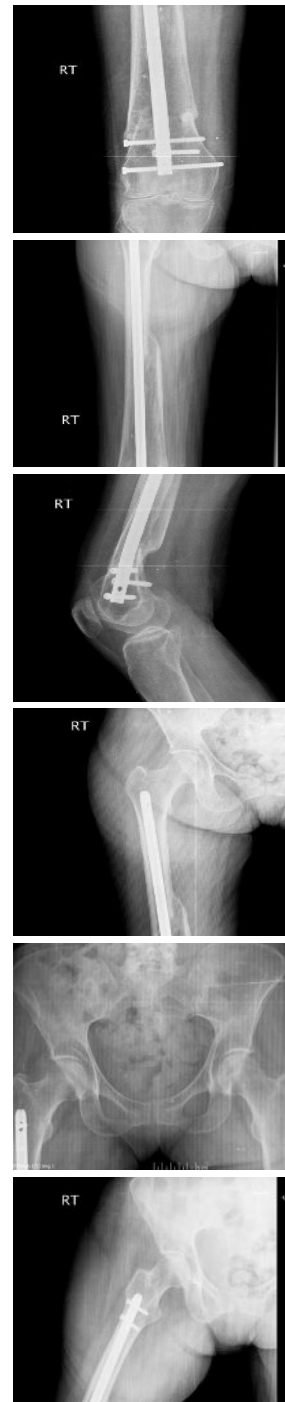
Radiographs obtained in the office demonstrate a healed fracture of the distal femur at the metaphyseal-diaphyseal junction. A retrograde femoral nail is visualized with two proximal and three distal interlocking screws.

^ Case #2, Pre-Op X-rays

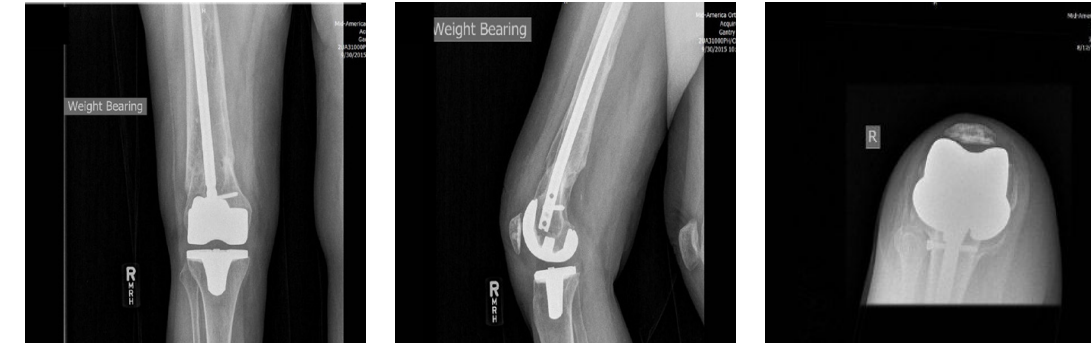
^ Case #2, Post-Op X-rays

At her six week post-operative visit, she was doing well and was pain free. Her incision had healed without any complications. She had been performing outpatient physical therapy and achieved good range of motion from 0-125 degrees. Her knee was stable on exam and well-aligned radiographically. She was walking unlimited distances without any assistive device and she was using stairs in a reciprocal manner with a rail. Her objective Knee Society Score was 100 and her functional Knee Society Score was 90. At this point, she was instructed to continue working on range of motion and strengthening as part of her home exercise program. Her next follow-up visit will be six months after surgery.

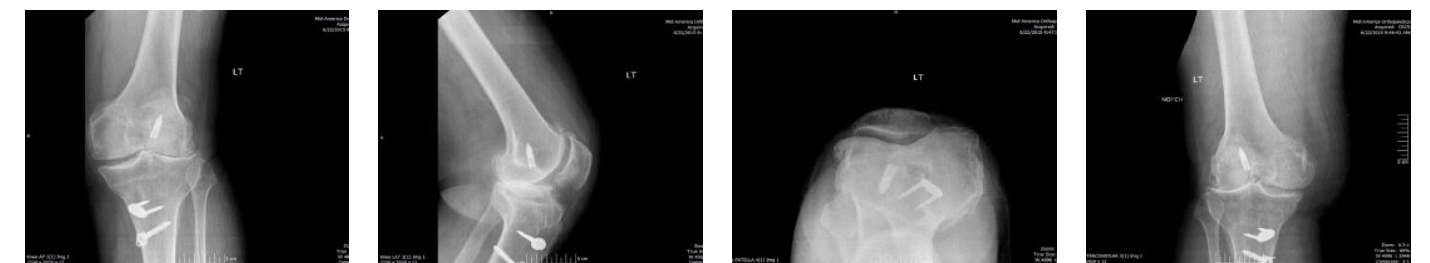
Radiographs obtained in the office demonstrate previous ACL reconstruction with interference screws in both the femur and tibia as well as a staple in the tibia. There is loss of lateral and patellofemoral compartment joint space with significant sclerosis and osteophyte formation. Examination reveals a five degree valgus deformity with range of motion from 5-120 degrees. There is lateral and patellofemoral compartment crepitation through a range of motion, as well as tenderness to palpation.

^ Case #3, Pre-Op X-rays
